Office of Structural Materials

Contract #: 04-0120F4Cty: SF/ALA Rte: 80 PM: 13.2/13.9File #: 99.28**WELDING INSPECTION REPORT****Resident Engineer:** Pursell, Gary**Address:** 333 Burma Road**City:** Oakland, CA 94607**Report No:** WIR-002847**Date Inspected:** 04-Jun-2008**Project Name:** SAS Superstructure**OSM Arrival Time:** 2230**Prime Contractor:** American Bridge/Fluor Enterprises, a JV**OSM Departure Time:** 830**Contractor:** Japan Steel Works, Ltd.**Location:** Muroran, Japan**CWI Name:** N/A**CWI Present:** Yes No**Inspected CWI report:** Yes No N/A**Rod Oven in Use:** Yes No N/A**Electrode to specification:** Yes No N/A**Weld Procedures Followed:** Yes No N/A**Qualified Welders:** Yes No N/A**Verified Joint Fit-up:** Yes No N/A**Approved Drawings:** Yes No N/A**Approved WPS:** Yes No N/A**Delayed / Cancelled:** Yes No N/A**Bridge No:** 34-0006**Component:** Tower, Jacking and Deviation Saddles**Summary of Items Observed:**

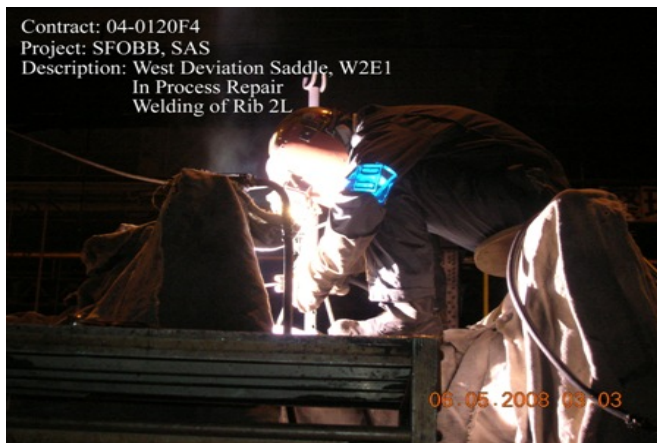
At the start of the shift the QA inspector traveled to the Foundry Shop to observe the continued repair build-up welding of the casting ribs on the West Deviation Saddle identified as W2E1. The QA inspector observed Japan Steel Works, Ltd. (JSW) welding personnel, Kazuya-Komai ID 06-8002 performing the welding on the rib identified as 2L, area 3-8.

The following digital photographs illustrate the observations of the activities performed on this date.
